DEPARTMENT OF TRANSPORTATION

Contract #: 04-0120F4Cty: SF/ALA Rte: 80 PM: 13.2/13.9File #: 69.28**WELDING INSPECTION REPORT****Resident Engineer:**Pursell, Gary**Address:** 333 Burma Road**City:** Oakland, CA 94607**Report No:** WIR-000412**Date Inspected:** 05-Sep-2007**Project Name:** SAS Superstructure**OSM Arrival Time:** 630**Prime Contractor:** American Bridge/Fluor Enterprises, a JV**OSM Departure Time:** 1530**Contractor:** Zhenhua Port Machinery Company, Ltd (ZPMC), Changxing Island **Location:** Shanghai, China**CWI Name:** Gu Xin Zhai**CWI Present:** Yes No**Inspected CWI report:** Yes No N/A**Rod Oven in Use:** Yes No N/A**Electrode to specification:** Yes No N/A**Weld Procedures Followed:** Yes No N/A**Qualified Welders:** Yes No N/A**Verified Joint Fit-up:** Yes No N/A**Approved Drawings:** Yes No N/A**Approved WPS:** Yes No N/A**Delayed / Cancelled:** Yes No N/A**Bridge No:** 34-0006**Component:** Mock Up, Check Samples**Summary of Items Observed:**

WELDING INSPECTION REPORT

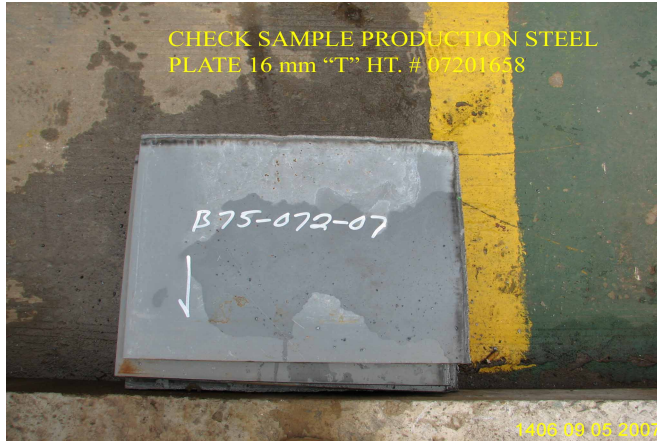
The QA Inspector was present at the time requested to observe the removal of 12 each check samples from 12 each production steel plates. The QA Inspector assigned Caltrans Lot Numbers B75-063-07 through B75-074-07 to the check samples. The Lot Numbers were written on the check samples along with the direction of rolling. The Lot Numbers, date, heat numbers, plate type/grade and plate thickness were all entered on the Check Sampling Tracking Log for Caltrans Project 04-0120F4.
